Stopping Sediment at its Source in the Rocky River Watershed

WATERSHED MANAGEMENT

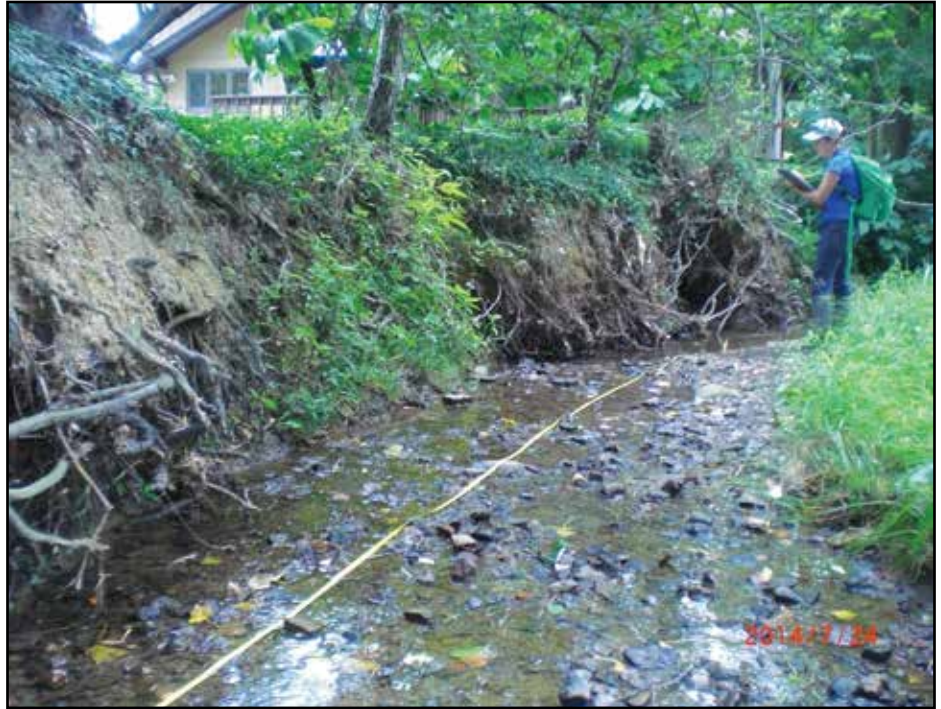
Above: Assessing streambank erosion in Baldwin Creek. Below: BEHI results are used to target individual properties for streambank stabilization assistance.

tributaries were evaluated using a modified Bank Erosion Hazard Index (BEHI) protocol. Developed by Dave Rosgen, BEHI is a rapid assessment protocol that considers streambank protection (roots, vegetation, natural armoring such as embedded boulders or bedrock), streambank angle, stratification, and streambank materials. You can quickly score a bank and rank it as having low to extreme potential for erosion. Notably, 24% of banks assessed were ranked high to extreme.

In order to identify and prioritize streambanks for stabilization, Cuyahoga Soil & Water Conservation District (SWCD) performed streambank erosion assessments throughout Baldwin Creek.

Over ten stream miles were assessed by Cuyahoga SWCD staff with the help of volunteers from the Cleveland Metroparks Watershed Volunteer Program. The entire main stem of Baldwin Creek and targeted
